# Cultural Landscape Information

# Conditions Assessment Report

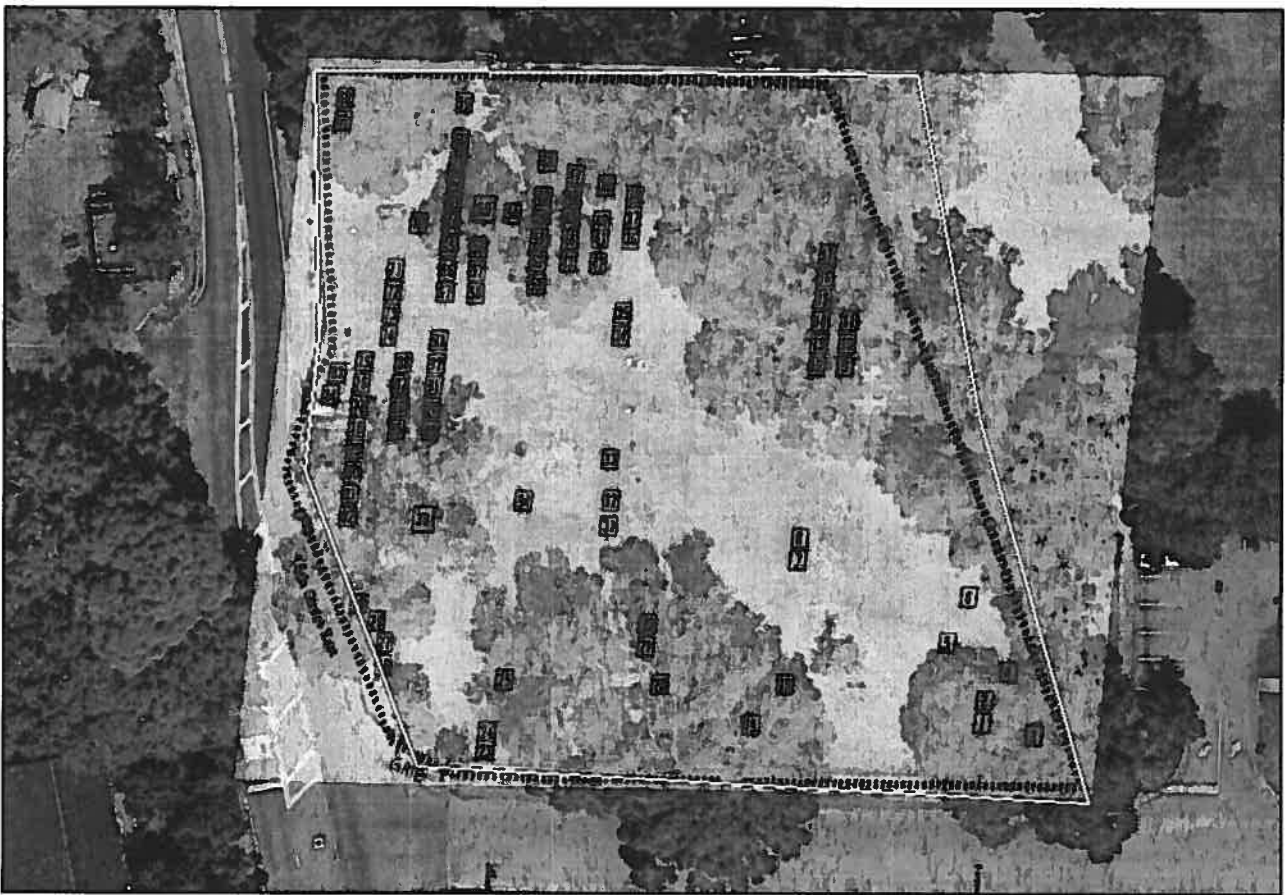
Figure 20. An aerial of Manatee Burying Ground with current fence line (yellow) and 4H map overlaid.

Additional exploration of historic maps and property records would be beneficial to determine if the boundaries of the Burying Ground have changed at all over time. Searches of historic Sanborn maps did not yield any information for this area of Bradenton, nor did historic topographical maps.

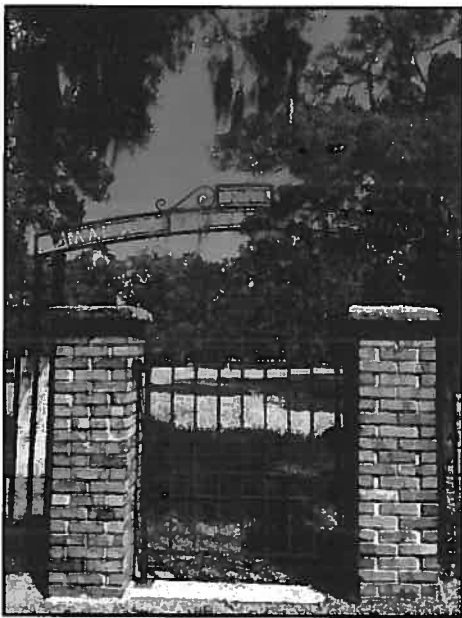
*Figure 23. Main entry to Manatee Burying Grounds, located on the corner of 15<sup>th</sup> Street E and 6<sup>th</sup> Avenue East.*

Although the cemetery has a very distinct entry gate, erected in 1958, it is located on the corner of 15<sup>th</sup> Street East and 6<sup>th</sup> Avenue East. The cemetery lacks signage along the main road, Manatee Avenue. Furthermore, the cemetery located behind a commercial building on the corner of 15<sup>th</sup> Street E and Manatee Avenue, hiding all evidence of the local landmark.

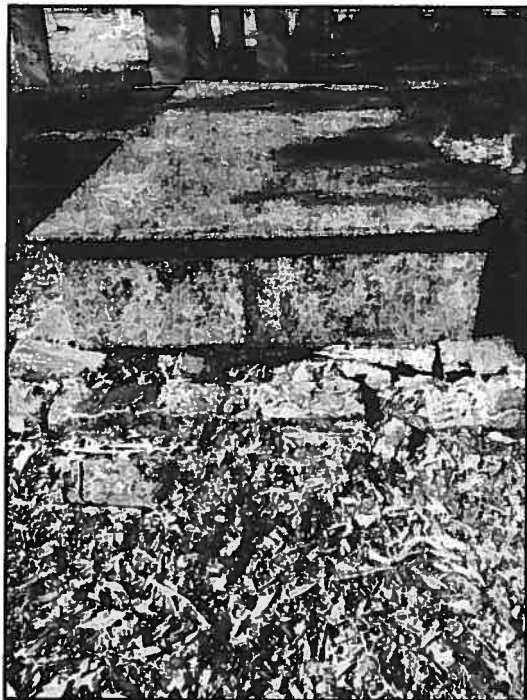
*Figure 25. Broken base of vault.*

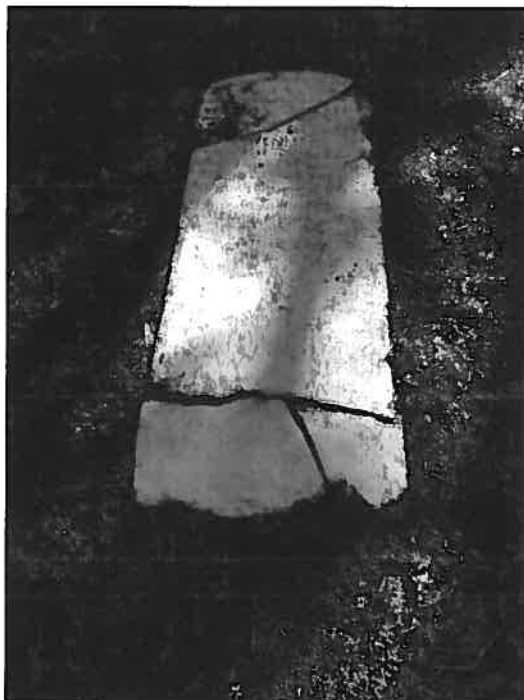
Vaults, ground tablets, and fallen vertical tablets have been covered with debris and therefore are no longer easily detected. If they are visible on the surface, they are in danger of being removed from the site altogether. Furthermore, they can pose a significant safety hazard as well as deterioration of the resource (Figure 24 and Figure 26).

*Figure 24. Broken headstone in danger of loss.*

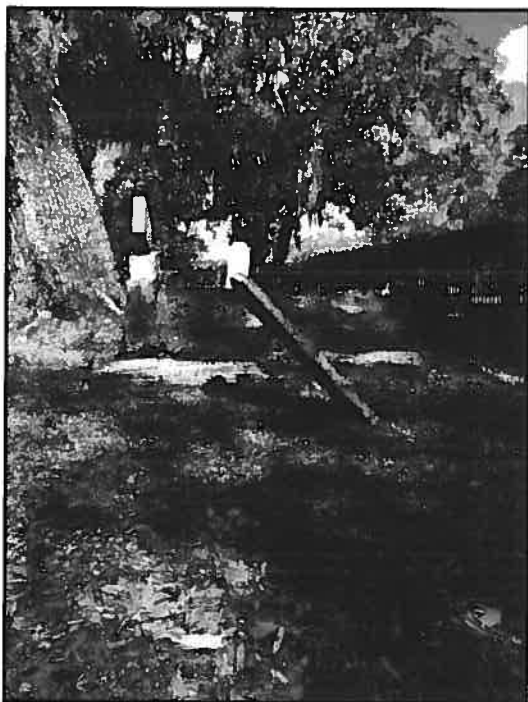
Many markers have fallen or have sunk into the soil. These markers are in danger of being lost as a resource as they are unidentifiable unless found by special probing or other more technical investigative practices (Figure 26).

*Figure 26. Fallen headstone in danger of loss or damage.*

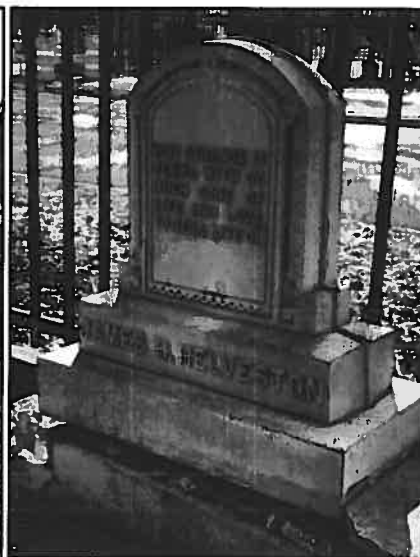
Figure 27. The zinc marker belonging to James Helveston.

There are a variety of markers included in the Burying Ground, primarily constructed of granite, concrete, brick, and in one unique circumstance, zinc (James Helveston). Some burials are underground with markers above ground, and other burials are in above-ground barrel vaults.

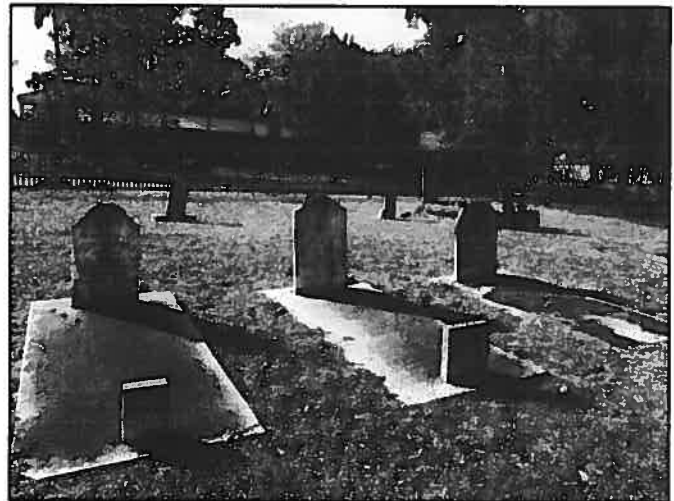
Figure 29. Markers in Manatee Burying Ground.

A variety of markers were observed at Manatee Burying Grounds including granite, concrete, brick, and in one unique circumstance, zinc (James Helveston). Most grave markers are headstones, although some burials are in above-ground vaults.

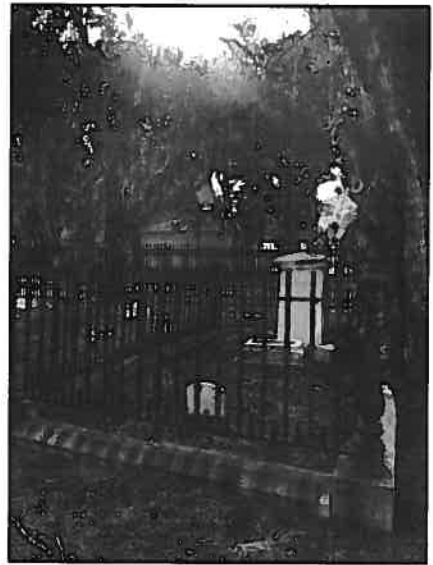
Figure 30. The Griffin enclosure.

Only one family plot, the Griffins, has an extant wrought-iron fence enclosure, although it is impacted by a large tree. In other portions of the Burying Ground, there are metal remnants that appear to have once been part of plot enclosures. It would be worth documenting the existing remnants to understand what family plots may have had enclosures in the past.

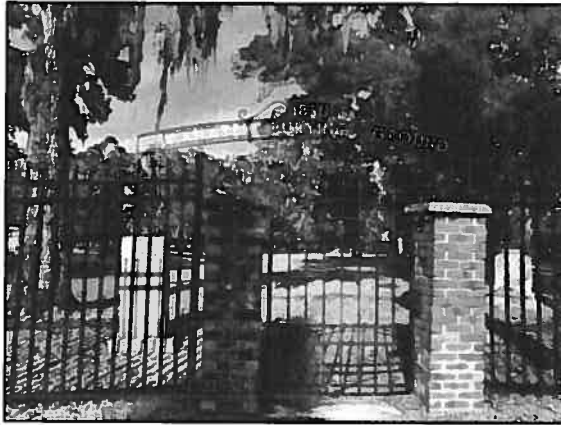
Figure 31. Entry arch.

A wrought iron arch at the southwest entry way to the Burying Ground says “1850 Manatee Burying Ground.” The arch is supported by masonry pillars. A nearby sign notes the arch was erected through the “efforts of the Judah P. Benjamin Chapter No. 1545, United Daughters of the Confederacy of Bradenton, Florida in honor of the many soldiers and civilians connected with the development of this section and the State of Florida who are buried here.” It was erected in December of 1958 and dedicated the following month.

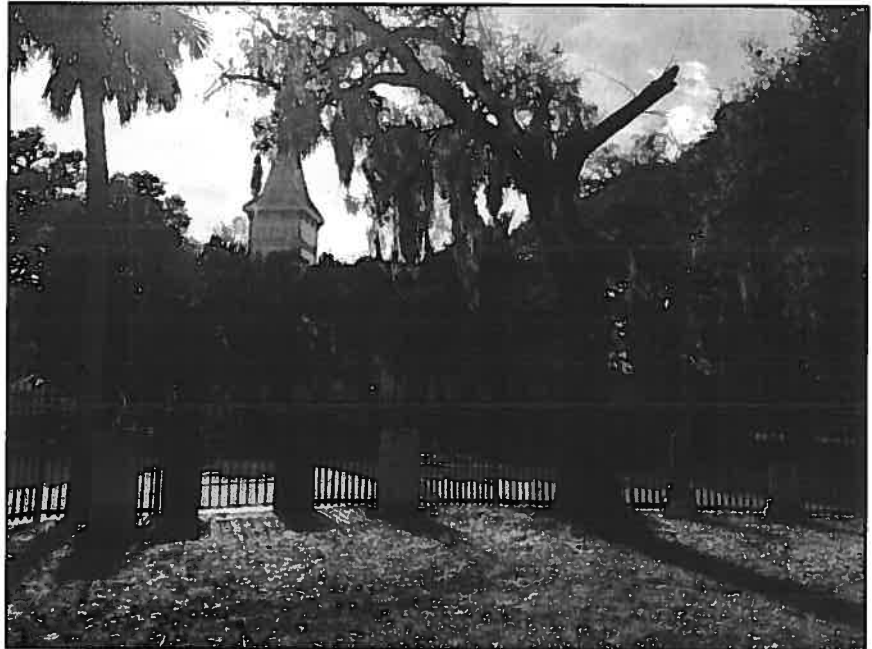
Figure 32. Looking west through a part of the cemetery across 15<sup>th</sup> Avenue East. Part of Manatee Village Historical Park is visible beyond the trees.

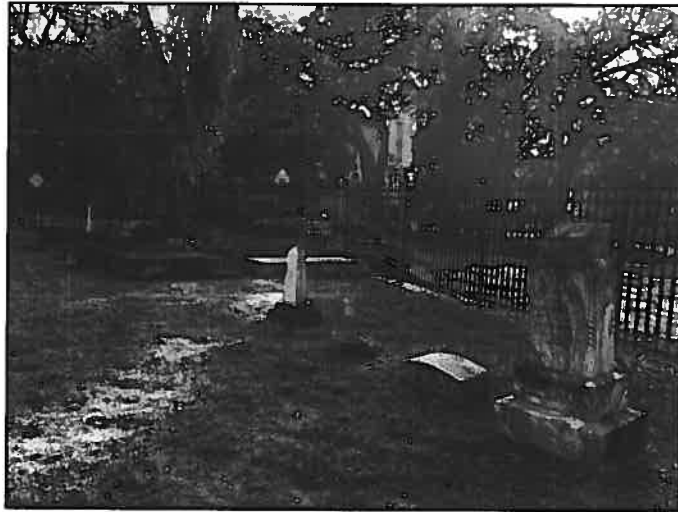
Figure 33. Looking south along the west fence line.

- Failing trees or limbs should be thinned and removed as soon as possible.
- Replacement trees should be native and slow growing
- New trees should not be planted in the same spot as the old ones but placed in nearby more open areas and be no larger than 4" in diameter breast height
- Planting a variety of species, as well as species with good groundcover is encouraged
- Non-hardwood trees, such as crepe myrtle or bottlebrush
